Manhole Inspection Summary

Manhole # S53M__062MH

Insp Date: 7/21/08 1:32 PM

Location Address: **rear 3133 dillon st**

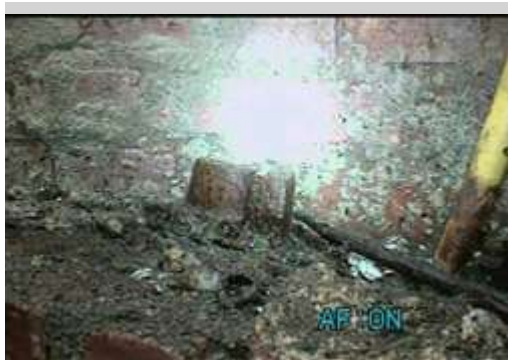
misc-1

bench debris

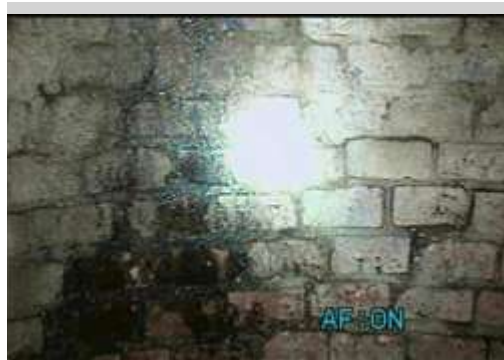
Defect 4

Infiltration: ☐ None ☐ Joint ☐ Cracks ☒ **Mortar** ☐ Roots ☒ **Wall**

barrel infiltration @ mortar & wall

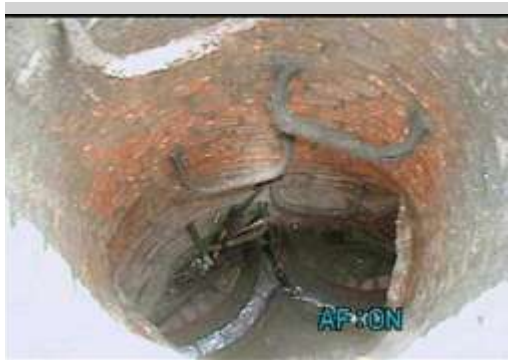
Defect 2

Steps Count: **5** Missing: **0** ☒ **Corroded**

steps

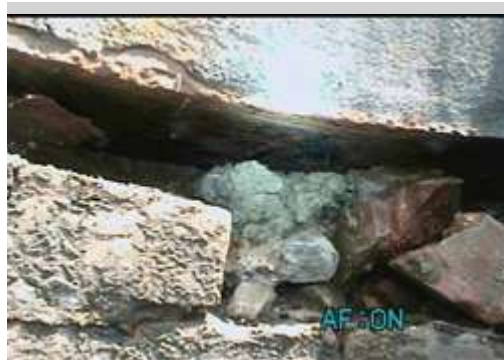
Defect 1

Condition: ☐ Sound ☒ **Cracked** ☐ Root Intrusion ☒ **Loose Brick** ☒ **Deteriorated**

chimney cond cracked, chimney cond loose bricks

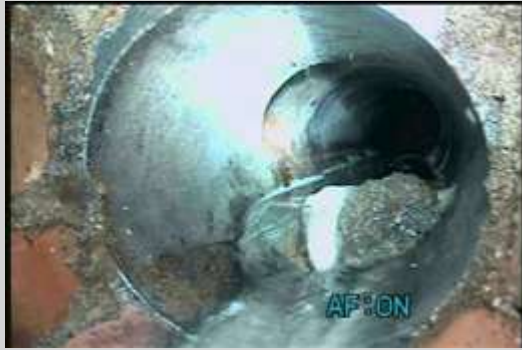
9 O'Clock Inflow

Deposits: ☐ None ☐ Mud ☐ Sludge ☒ **Debris** ☐ Grease

Silt Depth: **3** (in.) Deposits Extent: **Light**
